POST-INSTALLATION PERFORMANCE OF ECCENTRIC SCREW PILE UNDERPINNING SYSTEMS FOR RESIDENTIAL FOUNDATIONS

Konstantin G. Ashkinadze, Consulting Engineer, Edmonton, AB, Canada, Ph. 780-945-9746, email@k-the-eng.com

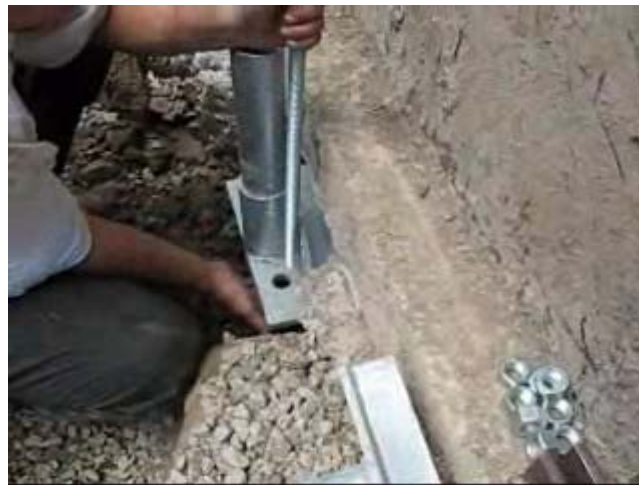
The other system considered is a Round Shaft (RS) system using tubular anchors (3.5" OD × 0.25" thick pipe section; 89 mm OD × 6 mm in metric), which provides for heavier-duty underpinning. The current design of the bracket in this system only allows vertical installation and the footing overhang is not being cut off (Fig. 2). Notably the design procedure in this system does not account for the installation eccentricity in the anchor design other than the 3" (76 mm) pile installation tolerance.

Fig. 2. Underpinning arrangement with vertical piles without cutting off the footing projection (RS).

For the RS anchors in the Fig. 2 configuration, a stable model could not be achieved within these terms, unless an external balancing moment is applied to prevent rotation of the foundation.

in Tables 1 and 2, respectively. It is seen that the Fig. 2 configuration is the most dependent on the additional restraint. The two configurations with the footing projection cut off and the pile battered are more stable and less dependent on the overlying floor diaphragm. The pile moments in this variant are formally within the acceptable limits but in the absence of the frictional restraint, the pile strength utilization ratio reaches 74% under very moderate loads. For larger loads, shaft bending would cause the anchor to fail prematurely and/or develop excessive settlement. The lateral deflection of the anchor also increases sharply if the frictional restraint at the bottom of the footing is not available.

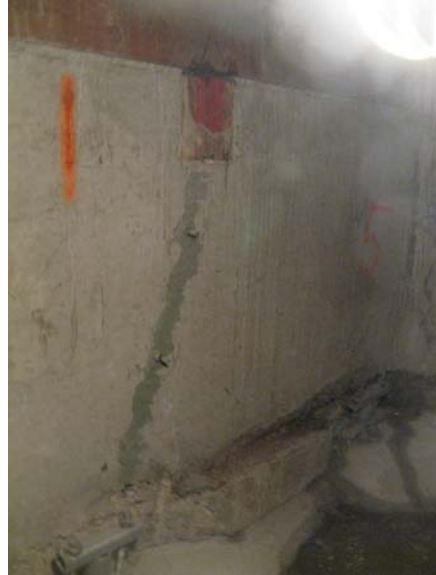
The condominium board contacted the engineer again over the Christmas holidays in 2013 with a complaint that the entry doors started to stick severely and new and larger cracks were appearing at the north end of the hallway. No problems had been experienced over the 4-year period until several days prior, when the outside temperature fell by 25°C in one day. The inspection showed that the suddenly increased heating demand caused a spray leak in a hot water manifold in the basement. The leaked water saturated the soil around the slender-shaft anchors and caused them to bend, which resulted in reopening of some of the previously closed and repaired cracks (Fig. 5). While this is not a situation normally considered in the design, the purpose of underpinning in the public opinion is to create a firm point of support off the deep soil strata, independent of what happens at the surface. Therefore, the underpinning system failed the expectations of the clients in this case.

Fig. 5. Reopening of previously epoxy-injected crack due to bending of anchors caused by upper soil saturation from a plumbing leak (Case Study 2).

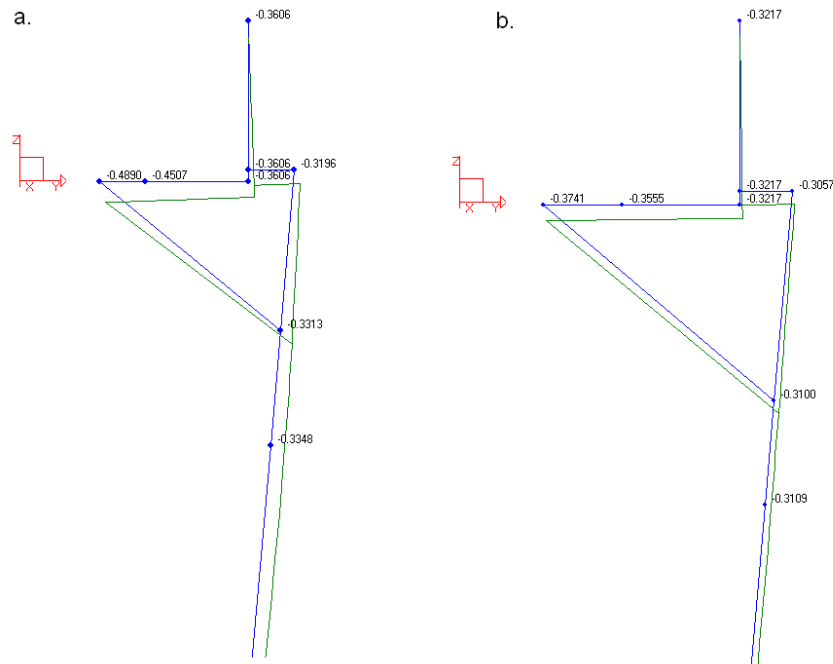
as in Fig. 1, the footing settlement reached 0.45" (11.4 mm) at the centerline of the wall stem and the moment in the anchor amounted to 3.28 kip-ft (4.45 kN-m), which exceeds the anchor allowable moment of 2.00 kip-ft (2.7 kN-m) determined as per the AISC Allowable Stress Design (ASD) steel design specification. For the 3.5" (89 mm) diameter RS anchor in the Fig. 1 configuration, the settlement was smaller (0.36" or 9.1 mm) but still considerable, and the moment in the pile (4.18 kip-ft or 5.7 kN-m) was just marginally less than the pile allowable moment of 4.36 kip-ft (5.9 kN-m) in the absence of compression. With consideration of compressive forces in the pile, the stresses in the shaft would also be excessive. Note that the loads applied were short of the listed allowable loads for these anchors. The patterns of anchor deformation and bending moment diagrams in the anchor are shown in Fig. 7 and 8.

Fig. 7. Vertical displacements at the head of battered anchors – no friction at footing base (inches; 1 in = 25.4 mm): a. – RCSS anchor; b. – RS anchor.
